NASA TECHNICAL MEMORANDUM 102594

**FATIGUE DAMAGE GROWTH MECHANISMS IN
CONTINUOUS FIBER REINFORCED TITANIUM
MATRIX COMPOSITES**

W. S. Johnson, R. A. Naik, and W. D. Pollock

January 1990

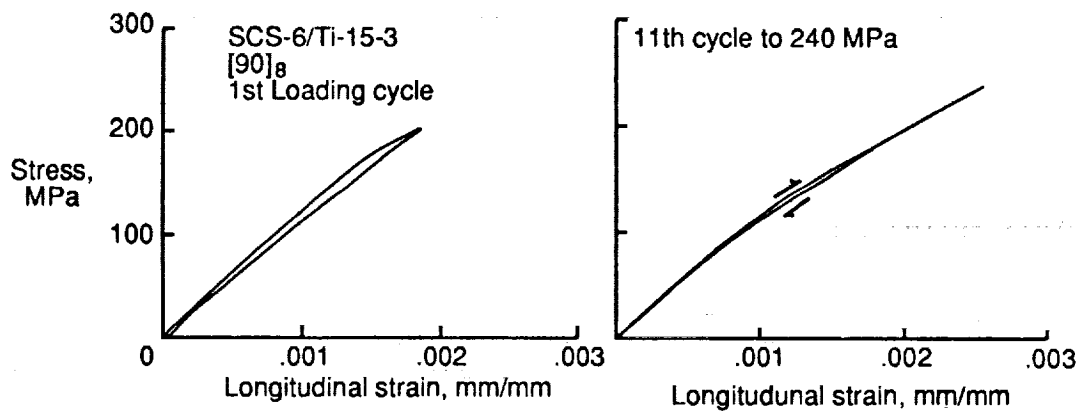
Figure 1. Stress-strain response showing nonlinearity due to fiber/matrix separation (3).

Static loading of SCS-6/Ti-15-3 laminates containing off-axis plies resulted in a knee in the stress-strain curve well below the stress level anticipated for the onset of matrix plasticity (3). Figure 1 shows the stress-strain response of a $[90]_8$ laminate. The knee in the first cycle occurred at approximately 155 MPa, well below the matrix material's minimum proportional limit of 690 MPa. The unloading elastic modulus was also less than the initial elastic modulus, thus, indicating that some sort of damage had occurred in the laminate. After the first cycle, the unloading curve closely

followed the loading curve, indicating an opening and closing phenomenon as shown in Figure 1 for the 11th loading cycle. This was due to failure of the fiber/matrix interface in the off-axis plies. This was determined using the edge replica technique (1,3). Reference (3) by Johnson, Lubowinski and Highsmith discusses in detail the fiber/matrix interface separation that occurred in these composites.

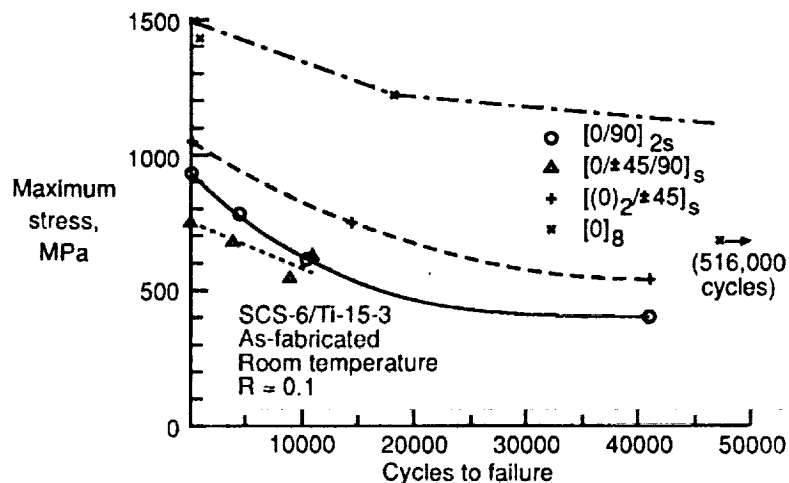
Figure 2. S-N curves for SCS-6/Ti-15-3 laminates containing 0° plies (3).

S-N data was experimentally determined at room temperature (RT) for four different lay-ups containing 0° plies as shown in Fig. 2 (3). The stress-strain response was monitored during the fatigue life. Laminates containing off-axis plies lost stiffness very early in the cycling history due to the fiber/matrix interface separations. After a few cycles, the stiffness stabilized and the cyclic strain range was recorded. This stabilized strain range was multiplied by the fiber modulus (400 GPa) to determine the cyclic stress range in the fiber. A plot of the 0° fiber cyclic stress against life for the different laminates is shown in Figure 3. The fatigue data

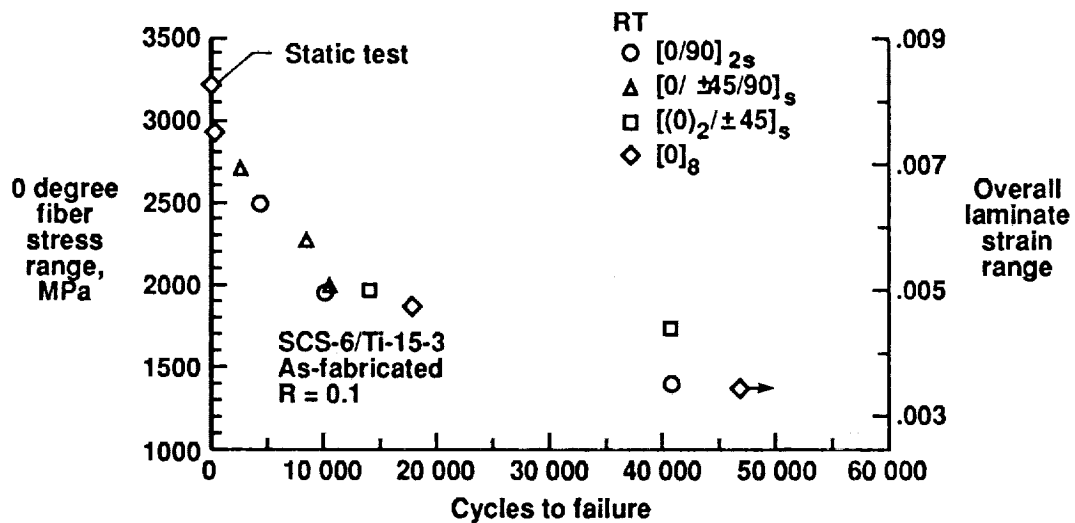
Figure 3. Cyclic stress range in 0° fiber versus number of cycles to laminate failure (3).

from the four different laminates was correlated very well by the 0° fiber stress. Since the laminate will not fail until the 0° fiber fails, it is reasonable to assume that the stress in the 0° fiber will dictate fatigue life. The measured stabilized strain range is also plotted against the number of cycles to failure in Fig. 3. It is important to note that the fiber failures were not necessarily the first damage to occur in these composites. The first damage that caused significant modulus changes was the failure of the fiber/matrix interface in the off-axis plies.

Naik and Johnson (6) recently reported fatigue test results from several laminates containing either double edge notches or center holes. The data shown in Figure 3 was used with a stress analysis to predict the remotely applied stress level required to initiate fatigue damage at a notch tip (6). The stress level for fatigue initiation was successfully predicted for a double edge notched $[0]_8$ laminate and for a $[0/90]_{2s}$ laminate containing a circular hole. This approach was also successfully used to approximate the number of cycles required to initiate fatigue damage for applied stress levels above the fatigue limit.

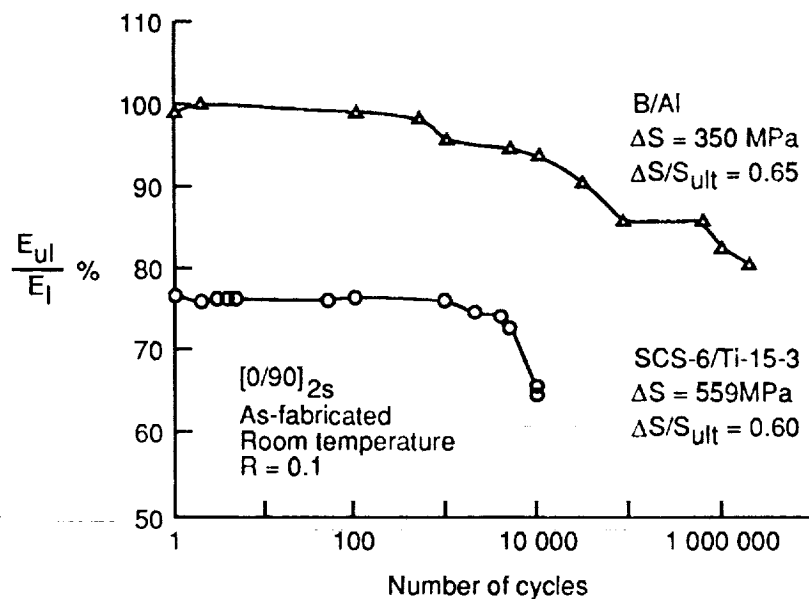
Figure 4. Change in the elastic unloading modulus for $[0/90]_{2s}$ layups of B/AI and SCS-6/Ti-15-3 (1).

Similar stiffness losses and loading-unloading responses were found for boron/aluminum and silicon-carbide/aluminum composites (1). However, for these systems, it took thousands of cycles to develop an equivalent stiffness loss to that occurring in just a few cycles for the SCS-6/Ti-15-3 system. Figure 4 presents a plot of the elastic unloading modulus (E_{u1}) divided by the initial elastic modulus (E_I) versus the number of applied cycles for $[0/90]_{2s}$ laminates of boron/aluminum (B/Al) and the SCS-6/Ti-15-3 (1). The elastic unloading modulus is a good indicator of the amount of damage in a composite. The elastic unloading modulus would be equal to the initial elastic modulus if the composite was undamaged. Both laminates were loaded such that the ratio stress range/ultimate strength was approximately the same. In the case of the B/Al laminate, damage initiated in the matrix material of the 90° plies and grew as a fatigue crack. Therefore, the B/Al stiffness did not drop during the number of cycles required for fatigue crack initiation. Once fatigue cracks were initiated the modulus slowly dropped with an increasing number of cycles until at 2 million cycles the unloading modulus had dropped by almost 20 percent. This is in sharp contrast to the SCS-6/Ti-15-3 composite for which the modulus dropped more than 20 percent in the first few cycles due to the fiber/matrix interface failure in the 90° plies. The modulus then remained almost constant until just before failure at 10,000 cycles. This illustrates how the damage process can affect laminate stiffness.

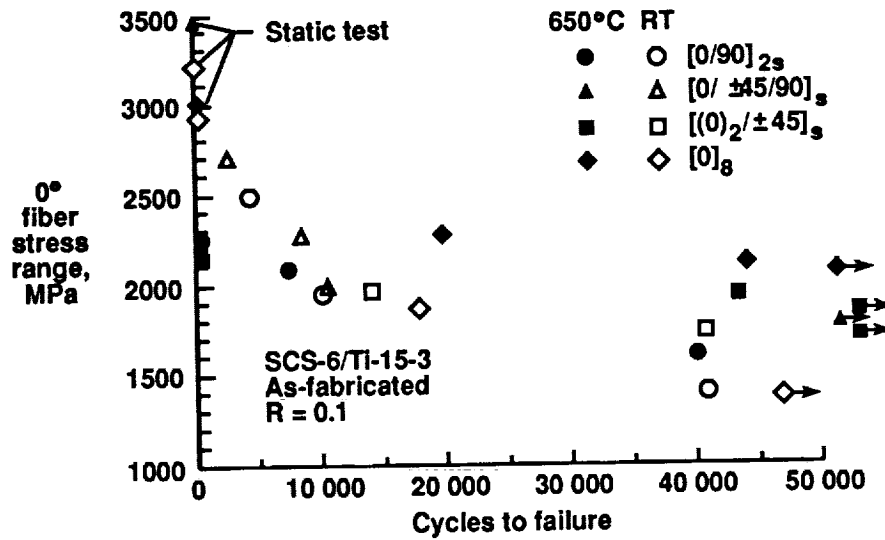
Figure 5. Fiber stress versus number of cycles to failure at 650°C and RT.

Unnotched fatigue tests were conducted at 650°C on the SCS-6/Ti-15-3 laminates discussed above. Once again the cyclic strain range stabilized after a few cycles. The cyclic stress range in the 0° fibers versus number of cycles to failure is plotted with the room temperature data in Figure 5. The elevated temperature data is more scattered than the room temperature data but all the data fall within a reasonable band.

The data correlation for both room and high temperature data indicates that it is the stress in the 0° fibers, and not the matrix, that controls the fatigue life. In fact, for a given strain range the stress state in the matrix material is completely different for each of the laminates tested. Indeed, the matrix stress state is different in each lamina orientation. Further, the matrix properties at 650°C are significantly different from those at room temperature, thus, the stresses in the matrix material would be significantly different at the two temperatures for the same laminate strain range. While the first fatigue damage may be at the fiber/matrix interface or in the matrix material, it is clear that laminate failure is controlled by the stress in the 0° fiber. However, the interfacial and matrix damage may well contribute to increasing the stresses in the 0° fibers.

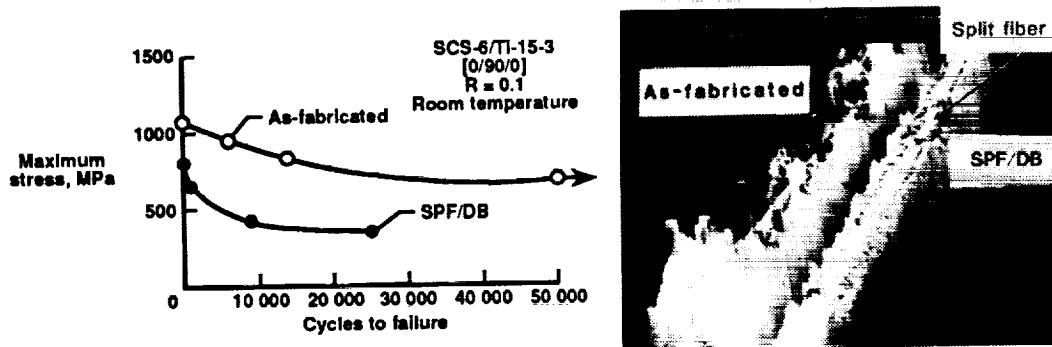
Figure 6. S-N curve for the laminates and their failure surface (5).

Naik, Johnson, and Pollock (5) investigated the effect of a high temperature conditioning cycle on the mechanical properties of a $[0/90/0]$ lay-up of SCS-6/Ti-15-3. Essentially the high temperature cycle (SPF/DB) increased the strength and stiffness of the matrix material, had little or no effect on the fiber properties, but significantly reduced the static and fatigue strength of the laminate as shown in Figure 6. Studies of the fracture surfaces in Figure 6 showed a change in the failure mode. In the as-fabricated (ASF) specimen the fiber/matrix interface was weaker and the thermal residual stresses were lower than in the SPF/DB specimen, thus the damage tended to grow around the fibers, debonding along the fiber/matrix interface. This produced a tortuous crack path in the matrix and extensive fiber pull-out. In the SPF/DB specimen the residual stresses were sufficiently high and the fiber matrix interface strong enough to cause the matrix cracks to grow directly through the fiber causing a very planar failure surface with little or no fiber pull-out. This latter failure mode resulted in a greater stress concentration in the fiber ahead of the crack, thus, explaining the reduction in strength of the SPF/DB specimen.

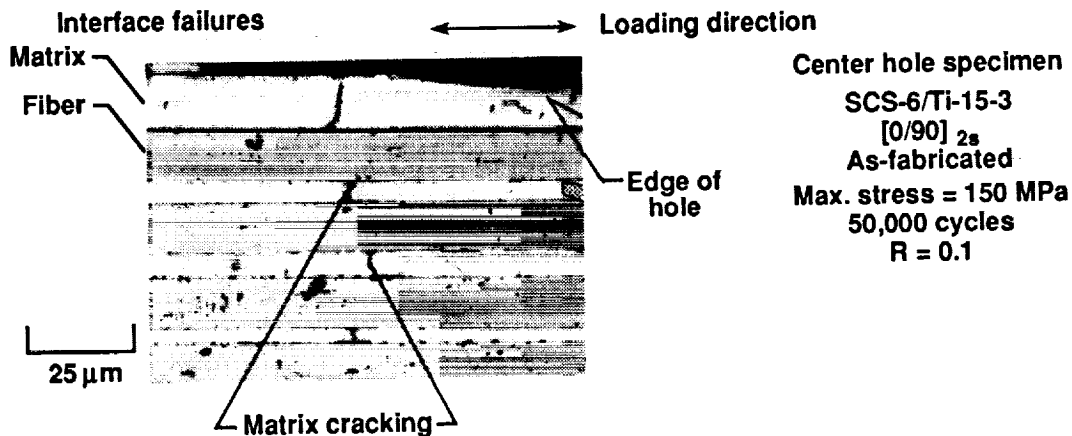
Figure 7. Matrix crack growing past fibers (6).

Fatigue cracks were observed in the $[0]_8$, $[0/90]_{2s}$, and $[0/90/0]$ laminates at cyclic stress levels above those required for crack initiation but well below the laminates' net section static strength. In each case the specimens were periodically radiographed during the tests to monitor fiber breaks. After the tests (but prior to specimen failure), the specimens surfaces were either polished or acid etched to reveal the matrix cracks and the fibers in the surface lamina. Multiple matrix cracks initiated and grew from the notches. Harmon and Saff (7) reported similar results. Figure 7 shows a matrix crack growing from the edge of a hole in a $[0/90]_{2s}$ specimen. The polished surface clearly shows that the matrix crack grew around and past the fibers. Also notice that next to the hole there is a long debond between the fiber next to the hole and the matrix on the side toward the hole. This type of debonding can significantly reduce the stress concentration at the edge of the notch. One can nominally predict the stress level at which the fibers next to the notch should fail, based on the applied loading and calculated stress concentration for the undamaged state. However, because of the type of initial damage shown in Figure 7 the stress concentration may be reduced to a level such that only the matrix would fail and not the fibers.
